USA-CERL SPECIAL REPORT M-89/02
November 1988

Assessment of the Structural Integrity of the People Center, Building 16, Chanute Air Force Base, IL

ASSESSMENT OF THE STRUCTURAL INTEGRITY OF THE PEOPLE CENTER, BUILDING 16, CHANUTE AIR FORCE BASE, IL

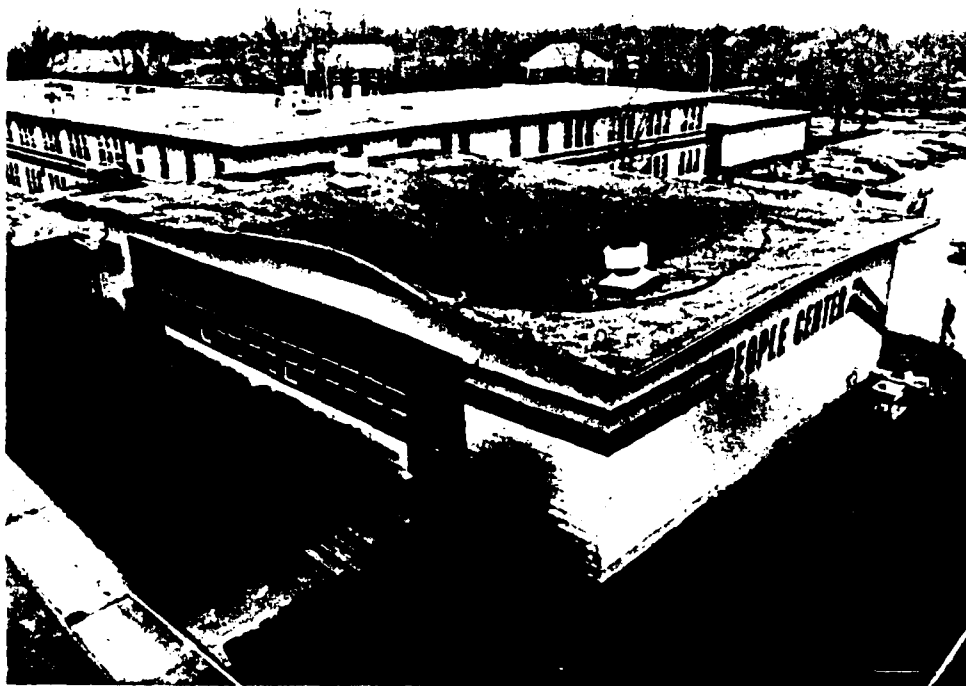
Due to the factors cited above, it is likely that the trusses deflected, the pitch became a depression, and rain and melting snow ponded on the roof. Ponding was observed the morning of the failure.

Figure 1. Ponding on the roof of Building 16.

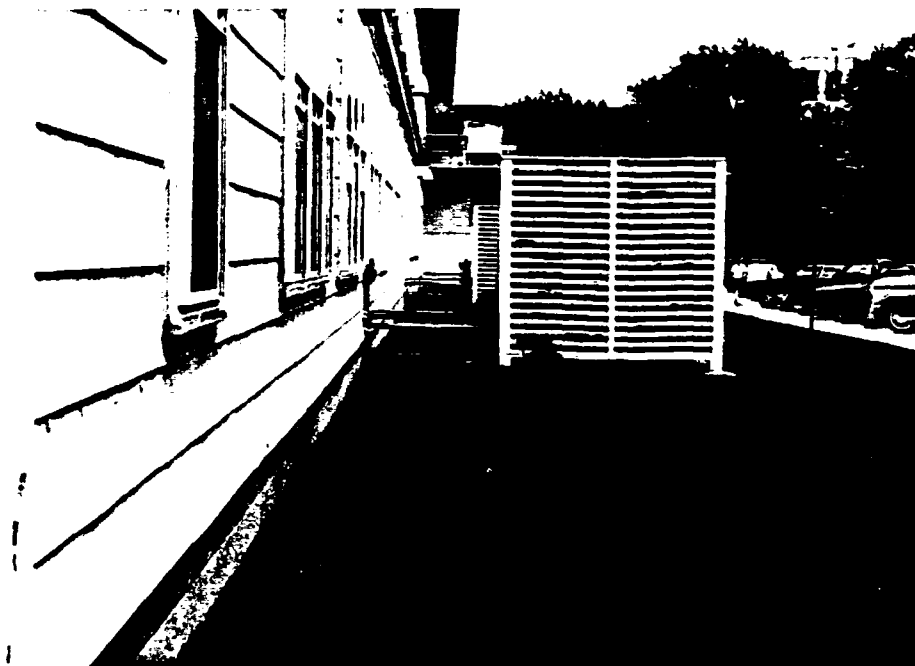
The building was inspected visually to assess the condition of the structural members, connections, and structural environment. A general inspection of the grounds and building exterior was conducted. In some areas, the ground surface around the structure is not sloped to drain water away from the building (Figure 12).

Figure 12. Ground slope around Building 16.

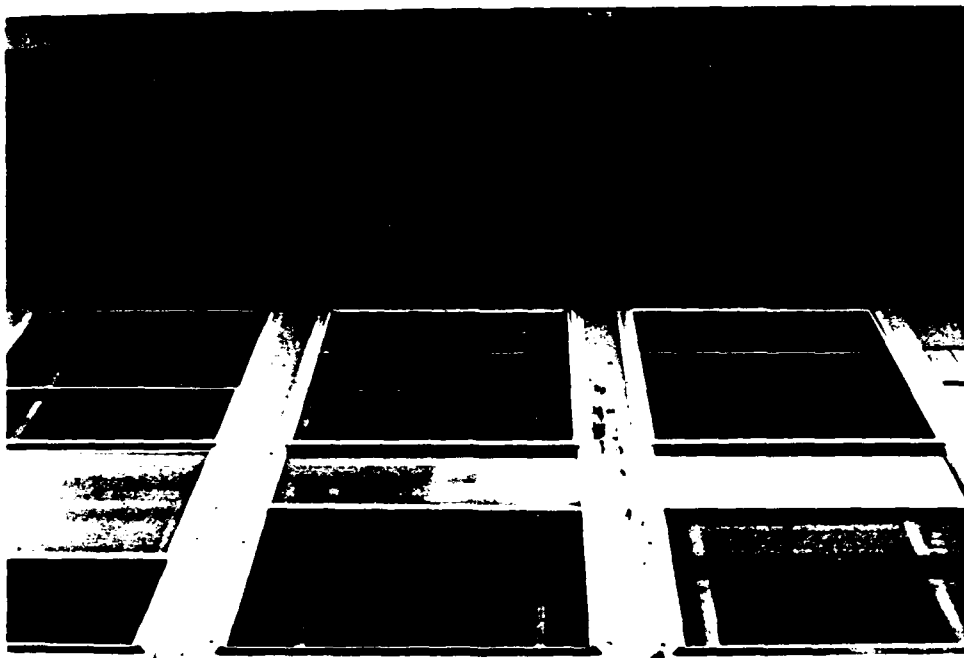
Figures 13 through 16 show the condition of the building elevations and roof overhang. Peeling paint was observed in the panels of wood sheathing on the underside of the roof overhang. This condition is typical around the building perimeter but is most pronounced on the east face. Here, water was observed dripping from the eave (Figure 17) and there is a depression in the ground underneath caused by dripping water (Figure 18). After a heavy rain, water also dripped from three roof locations along the south side of the west wing. These areas are directly over the window of Room 214, at the center window unit in Rooms 209 and 210, and between the first and second windows from the east end of Rooms 207 and 208. At the main entrance to the building on the south face, new plywood had been installed in the overhang and water stains could be observed (Figure 19).

Figure 15. Underside of roof overhang-view 2.

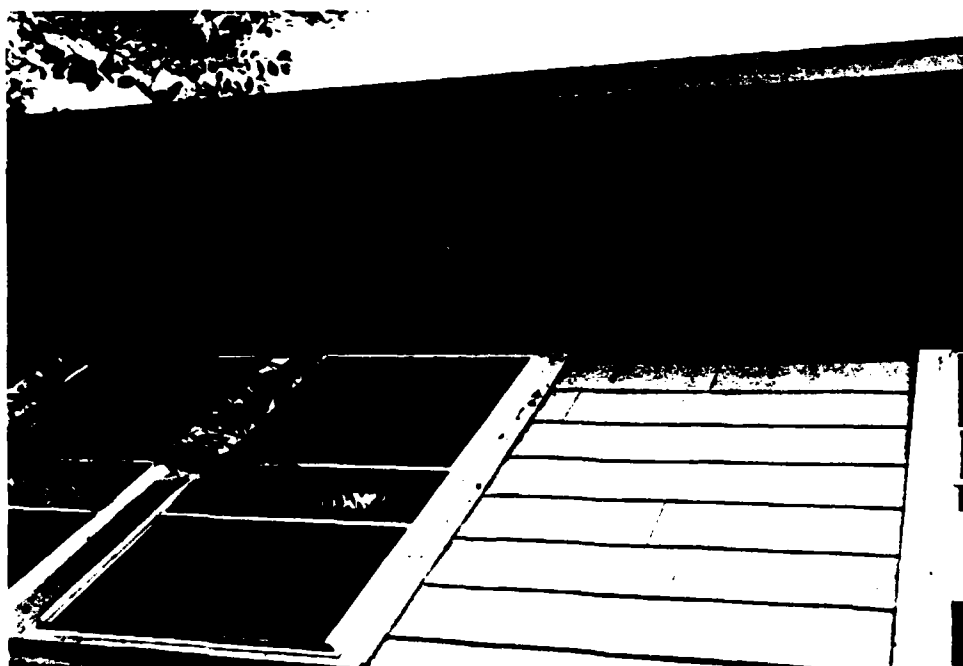
Figure 17. Underside of roof overhang on east side of north wing.

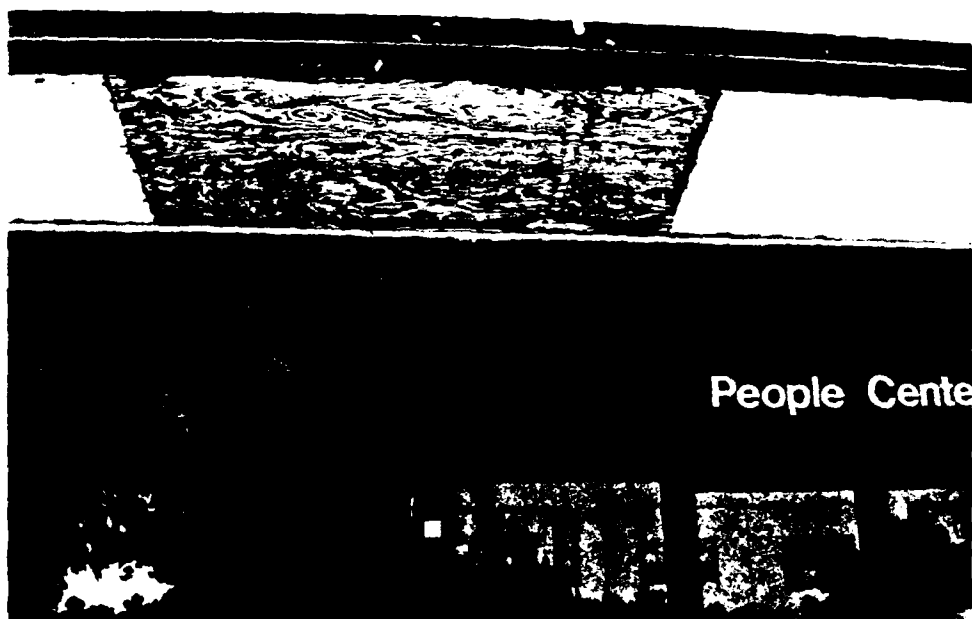
Figure 19. Stained plywood at entrance to Building 16.

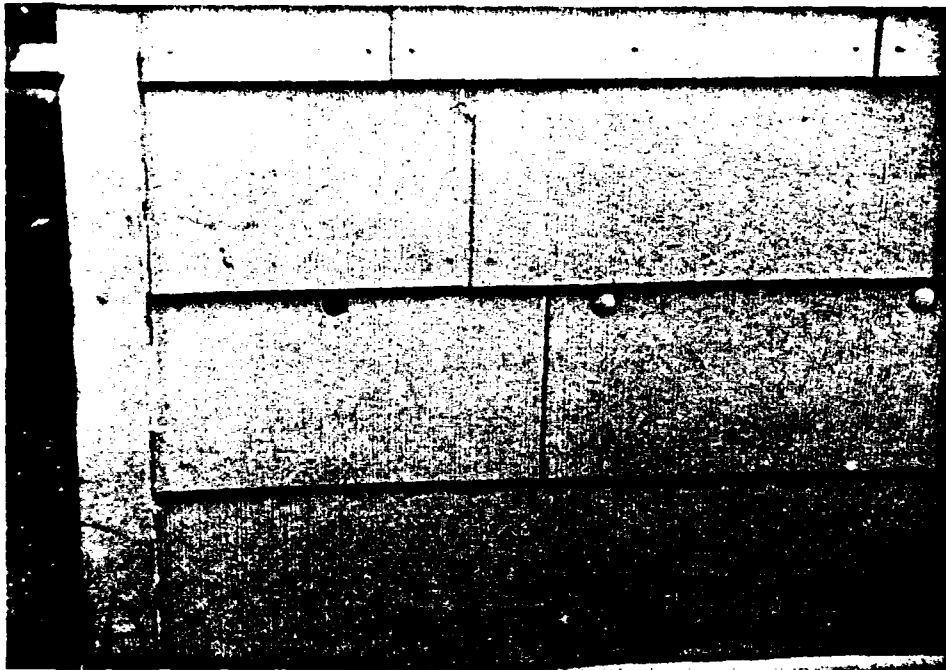
Some plugs are missing from holes in the building's exterior siding where the wall cavity has been filled. Figure 20 shows this condition.

Figure 20. Missing plug on exterior siding.

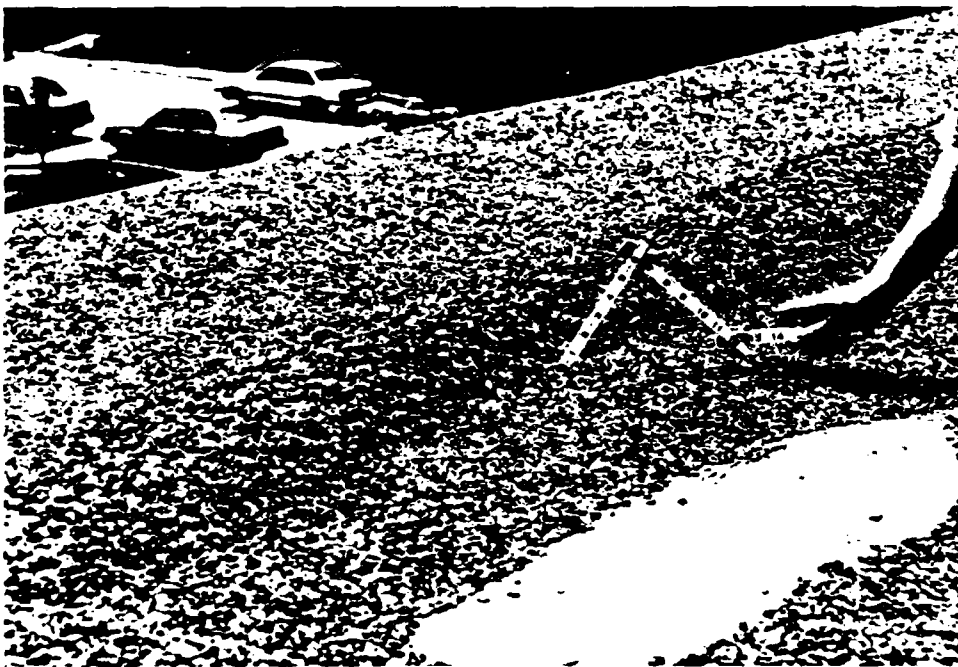
The roof survey indicated that several areas are significantly depressed such that ponding can occur and this observation was verified during the visual survey of the roof. The largest deflections in the roof surface are in the area between Lines 7 and 8 on the south side of the west wing and along the west side of the north wing, especially along Line 12, as was determined from the roof survey data. Dark pools of algae had formed in these and other depressed areas. Water could be forced from the roof overhang by stepping on its edge at the point above where the water was observed to be dripping on the ground. Bubbles in the roof surface were noted across the extent of the roof--especially along the line of the perimeter wall on the south side of the building (Figure 21). The roof on both wings had been patched in several locations (Figures 22 through 24) and unpatched tears in the roof surface were also noted (Figure 25).

Figure 21. Bubbles in roof surface.

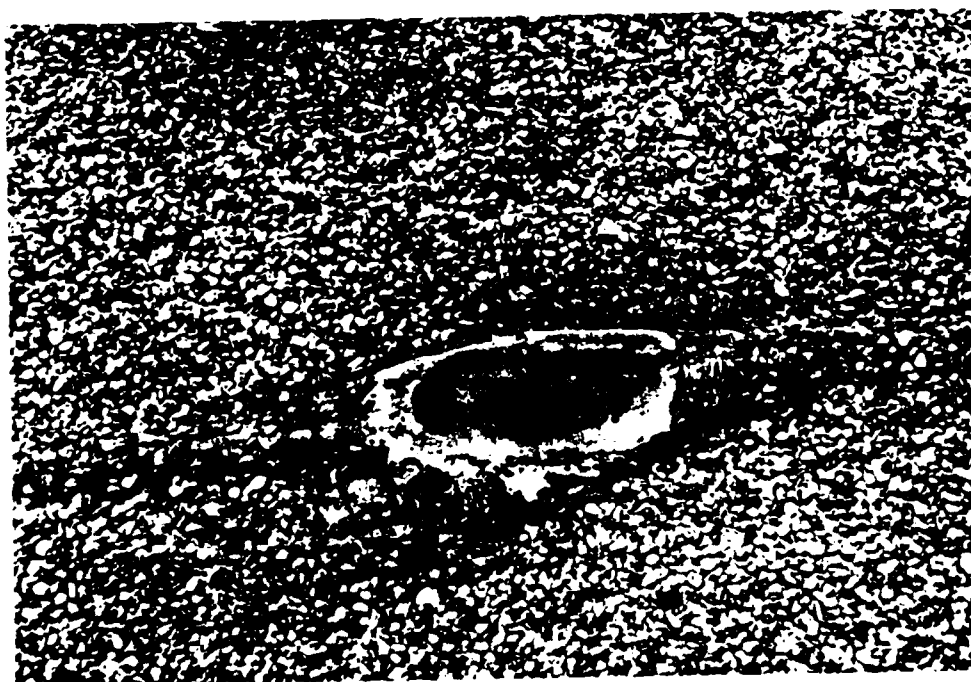
Figure 23. Detail of patch in roof surface.

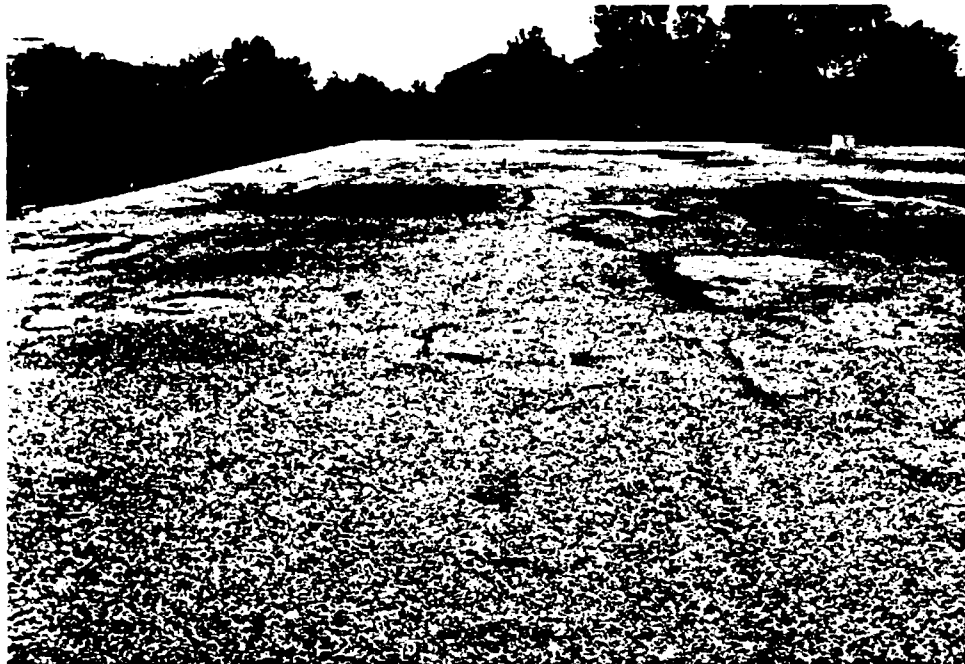
Figure 24. Several patches in roof surface.

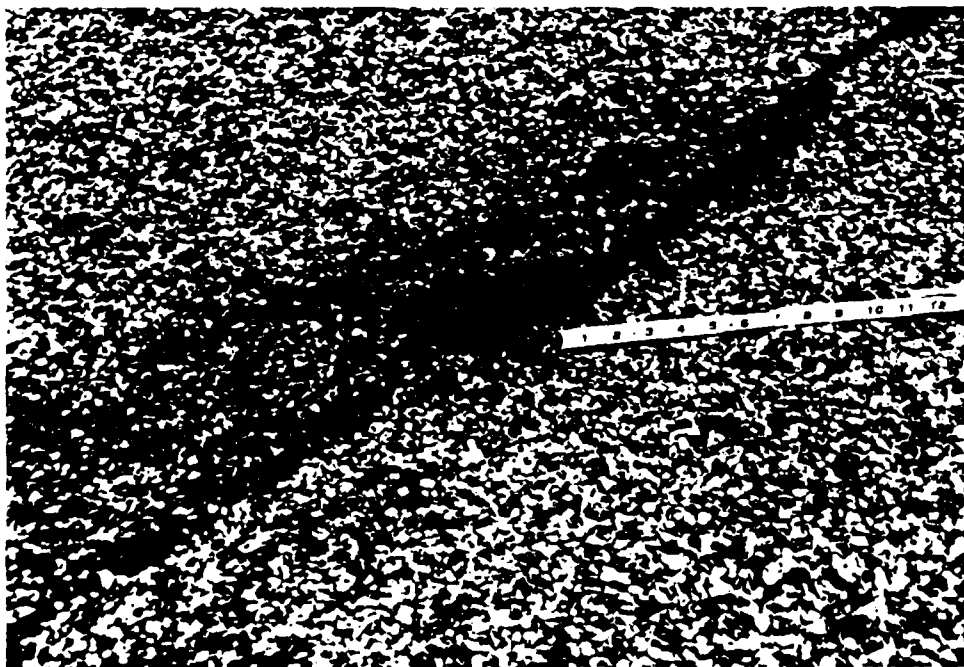
Figure 25. Unpatched tears in roof surface.

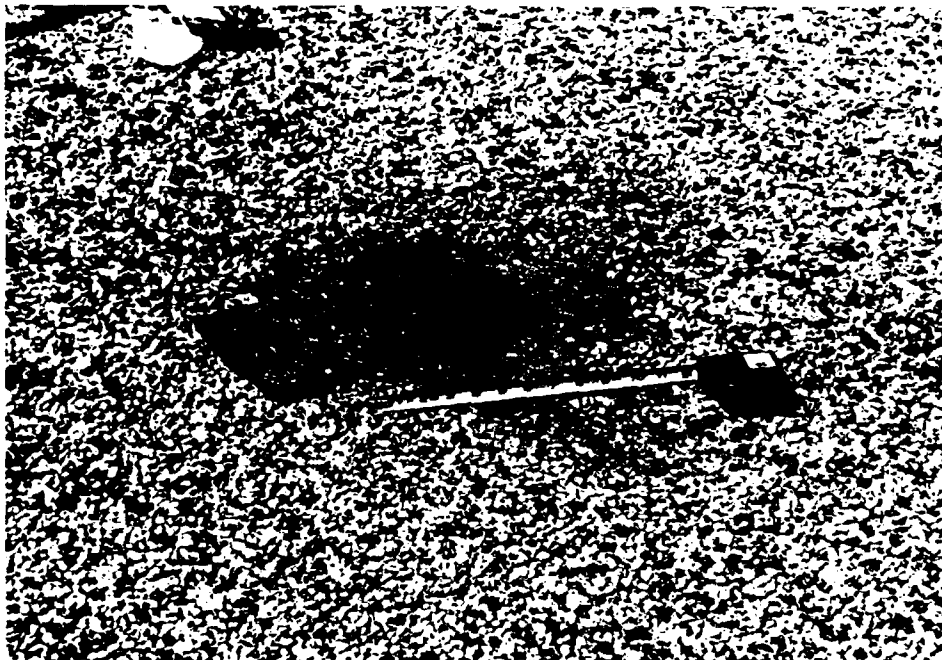
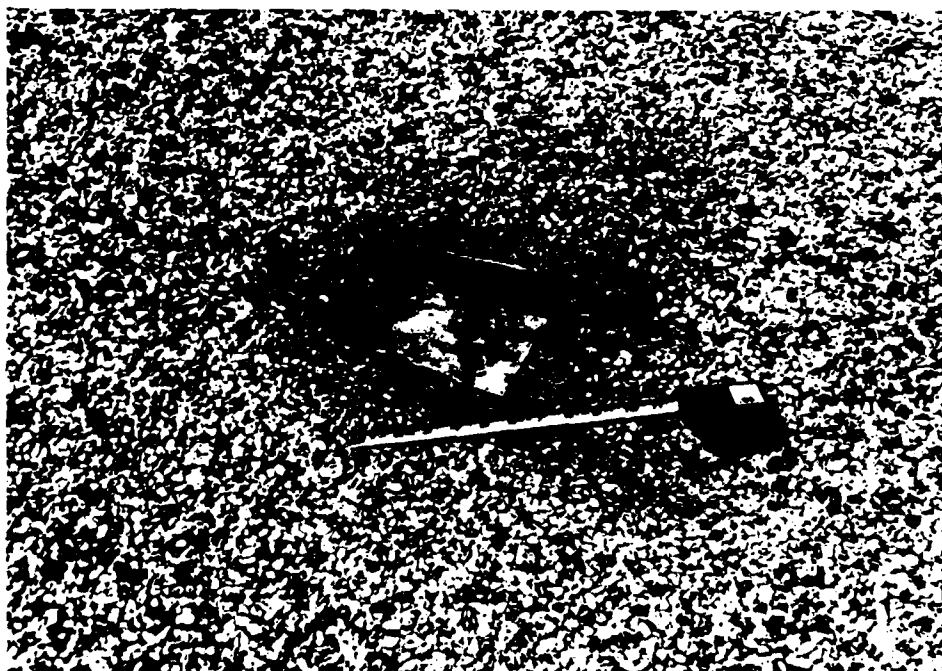
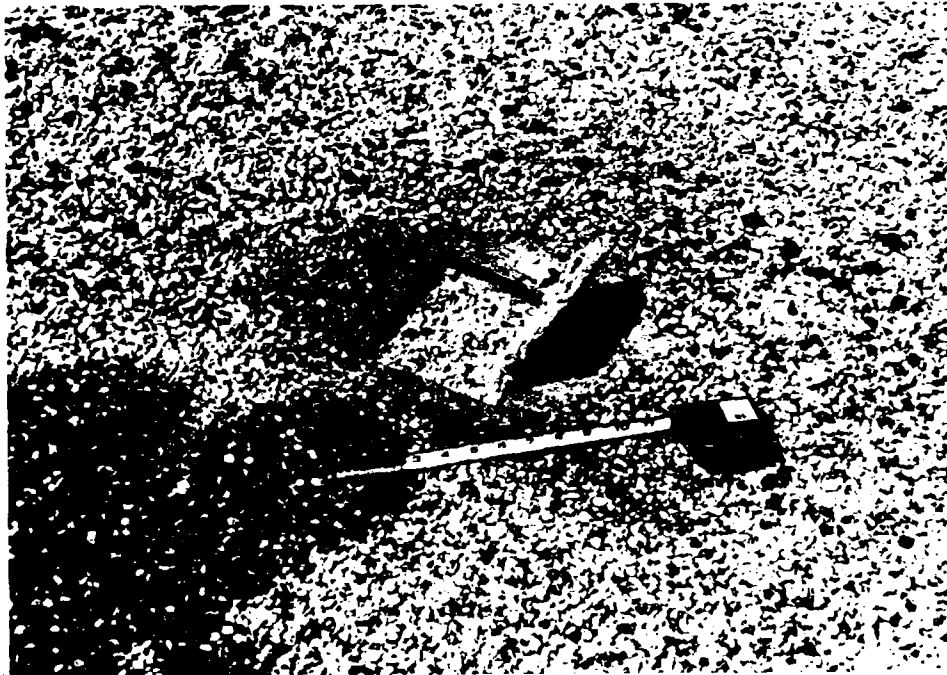
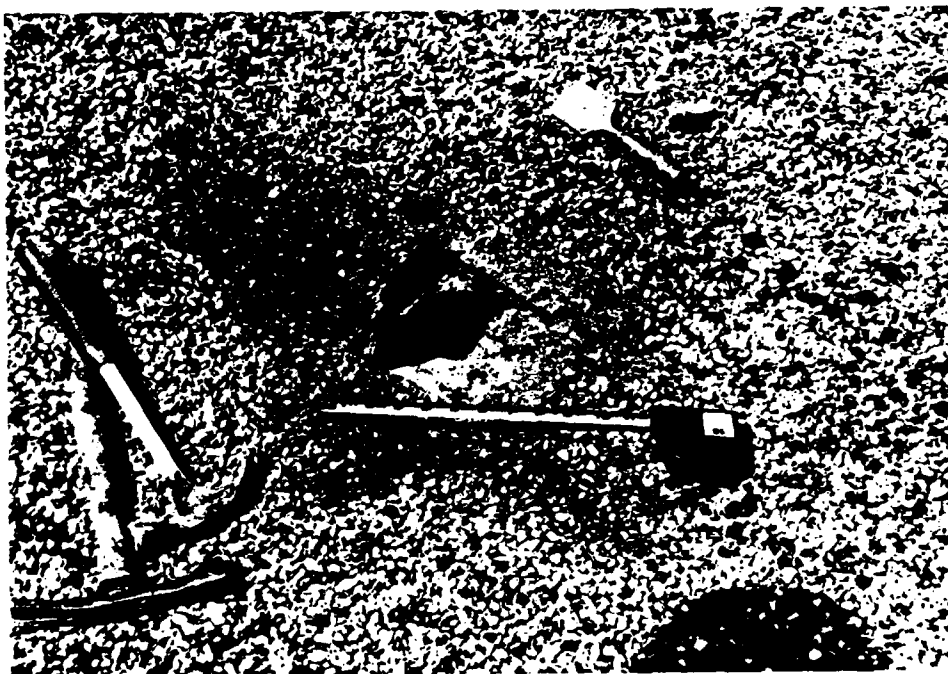
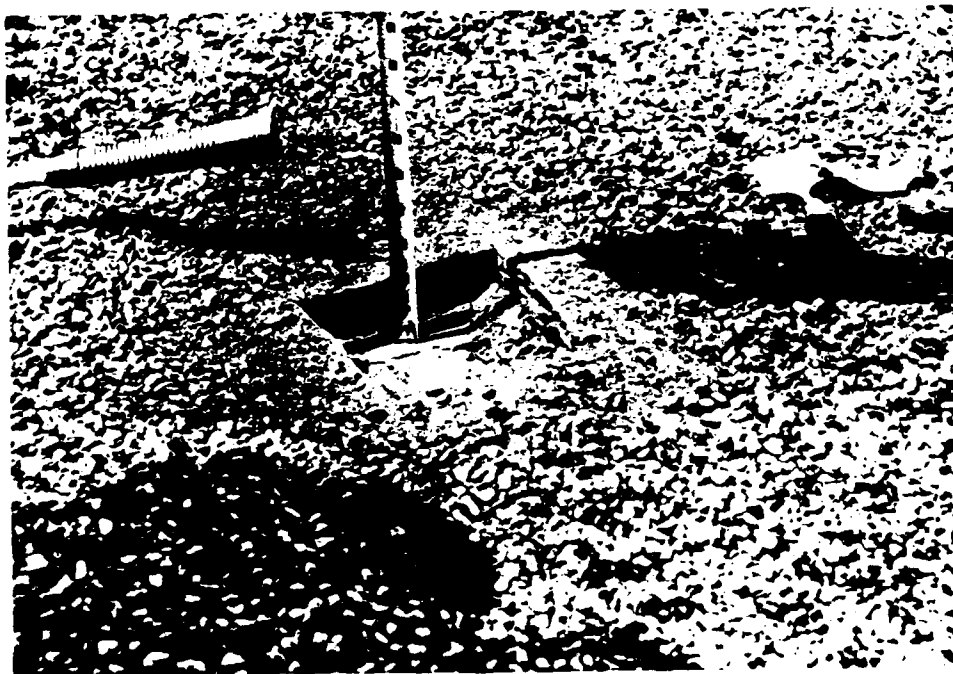
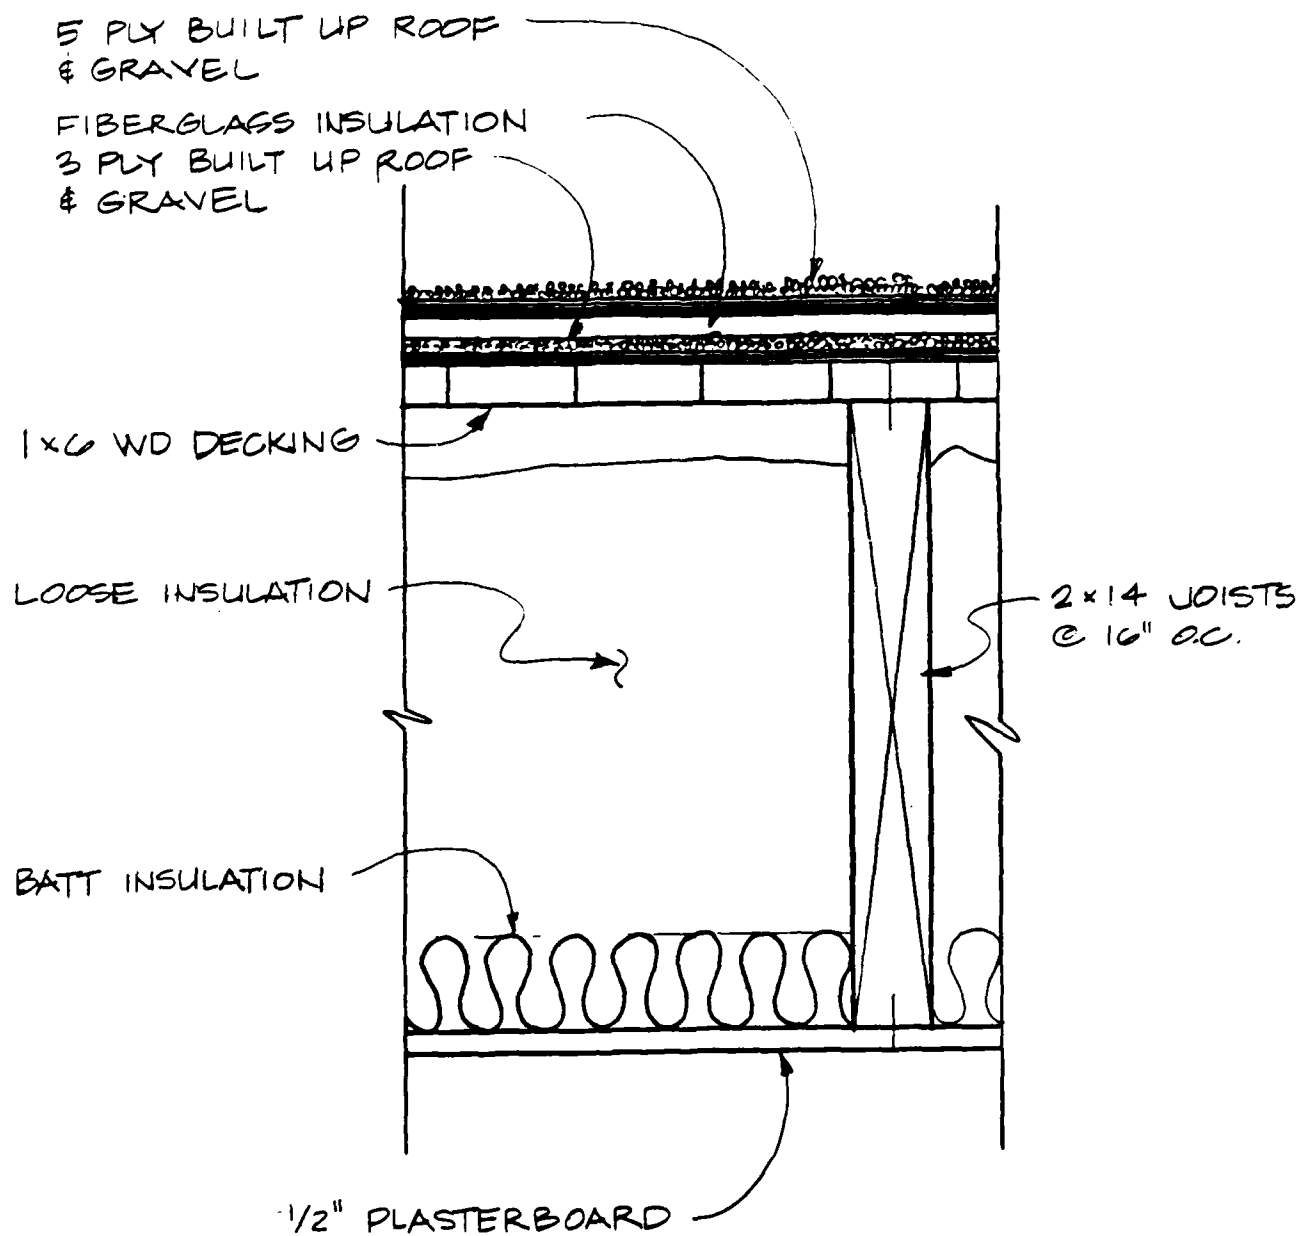
During another site visit, roof samples were taken in order to determine the number of roof membranes in place. Figures 26 through 31 show the exposed layers of the roof membranes. Two separate roofing systems were discovered. The uppermost system consists of gravel, 5-ply roofing, and approximately 3/4 in. fiberglass insulation. The original roofing system is constructed of gravel and 3-ply roofing. At this time, significant ponding was also observed on the roof (Figures 32 and 33). The metal flashing and gravel stop at the edge of the roof form a barrier about 3/4 in. to 1 in. higher than the roof surface. Consequently, the metal flashing and gravel stop contribute to the ponding problem by allowing an additional layer of water to accumulate on the roof.

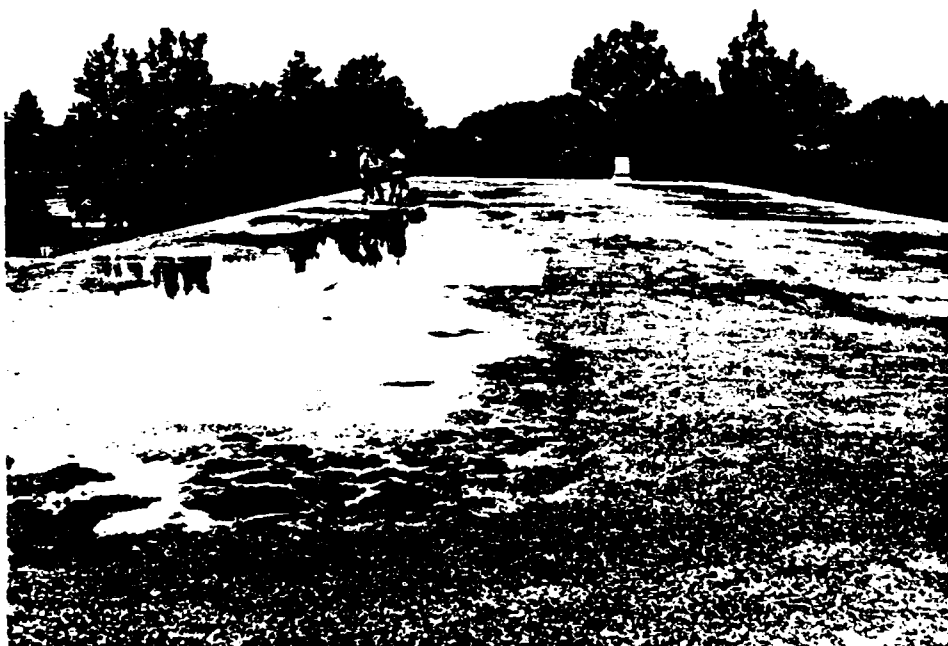
Ponding water on the roof is a major problem with Building 16. The original roof was designed to be a flat system with no slope or pitch. Moreover, no roof drains were provided and a 0.75 to 1 in. high metal flashing and gravel stop were installed around the entire perimeter of the roof, contributing further to the ponding problem. Current design guidance recommends that roof surfaces have a minimum residual slope or camber of not less than 0.25 in./ft of horizontal distance between the level of the drain and any point on the roof to minimize water ponding. This minimum slope should remain after long-term deflection of the members has taken place. (The general problems plaguing flat roofs are described, e.g., in Rosenfield.¹)

Based on this analysis, the reasons for the severe ponding problems on Building 16 are lack of slope, inadequate drainage, and additional dead loads.

Figure 32. Ponded water on south side of west wing.

1. Building 16 should be phased out as soon as a suitable replacement structure can be located, rented, or constructed. Although there is no immediate hazard to the occupants of Building 16, the potential for a failure exists. Conditions will only worsen if no action is taken.
2. Roof drains should be installed at numerous locations on the existing roof to control the ponding problem. Until such time that the roof drains are installed, the ponded water should be pumped from the roof following heavy rains that would create extensive ponding.
3. The stamping machine for making identification tags should be moved to the first floor.
4. Until Building 16 is vacated, it should be inspected quarterly to assess any additional evidence of distress and termite activity and to ensure that the roof drains are not clogged with leaves or other debris.

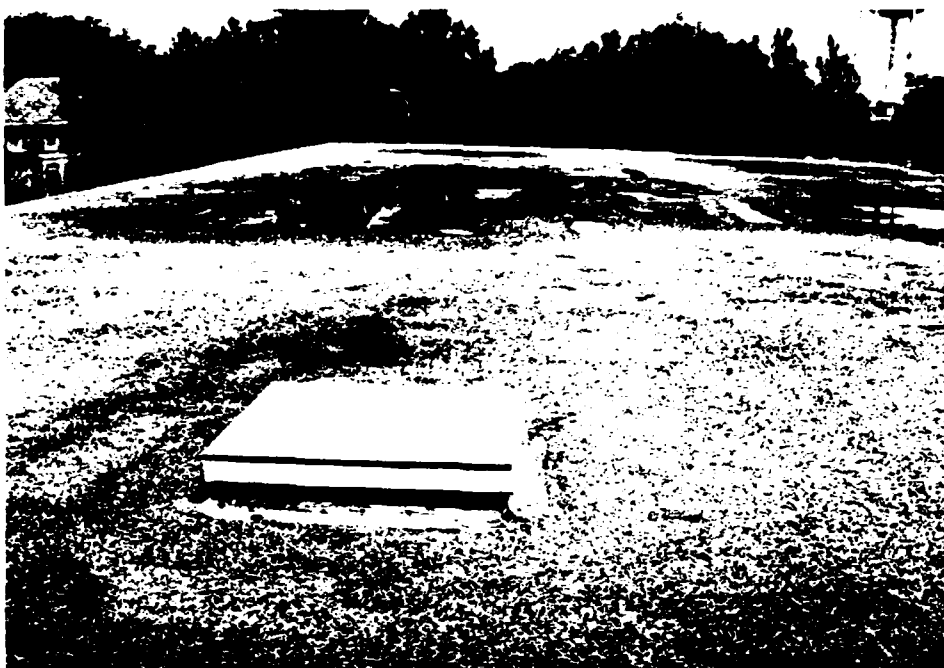
Figure 33. Ponded water on west side of north wing.

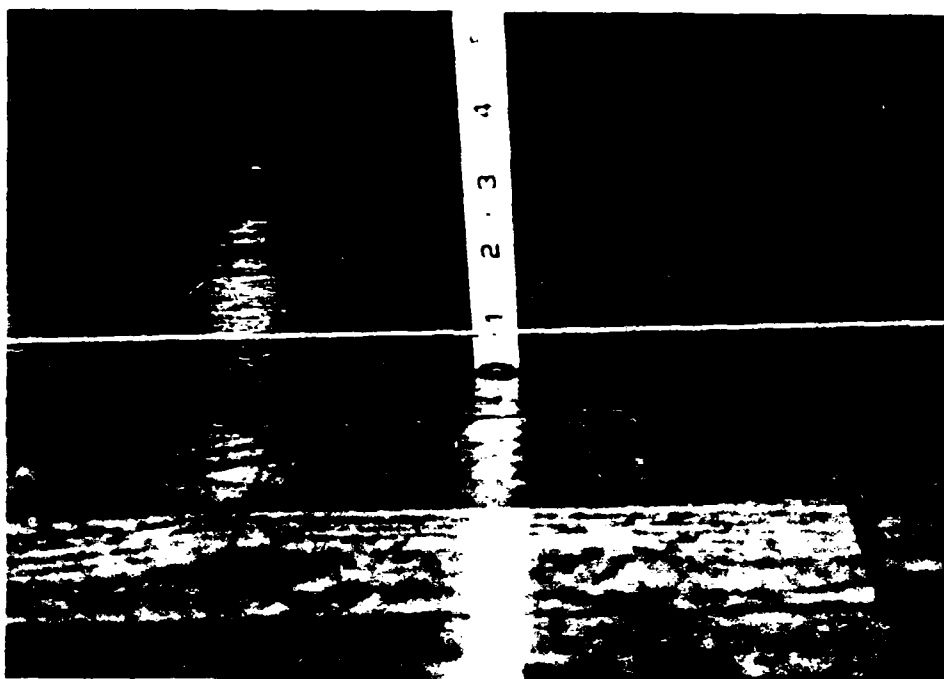
In Rooms 209 and 210, there are two major humps in the floor that coincide with the load bearing walls of the women's restroom on the south side of the first floor. The maximum deflection between the two humps is about 5/8 in. The exact cause for such a large deflection is unknown. Perhaps this area of the room was heavily overloaded with file cabinets or file drawers in the past. If so, the floor joists would transfer a major portion of the load to the header beam over the 11 ft wide first-floor window. If the overload had remained in place for an extended period, creep may have occurred in both the header beam and the floor joists which would have resulted in permanent deflection when the load was removed.

Figure 43. Deflection of floor in Room 210 between women's restroom walls below.

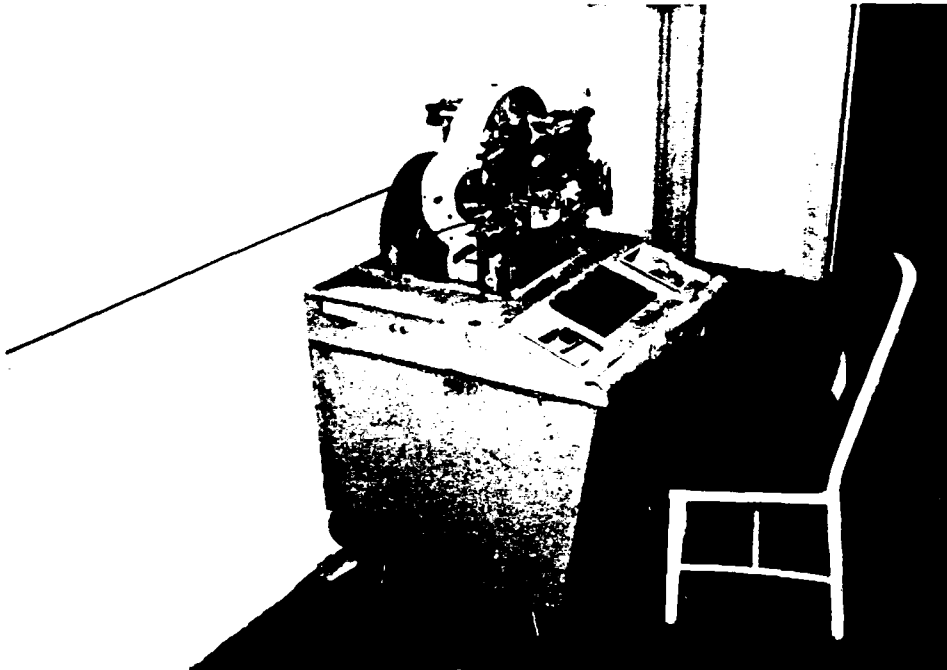
Figure 44. Stamping machine in Room 210.

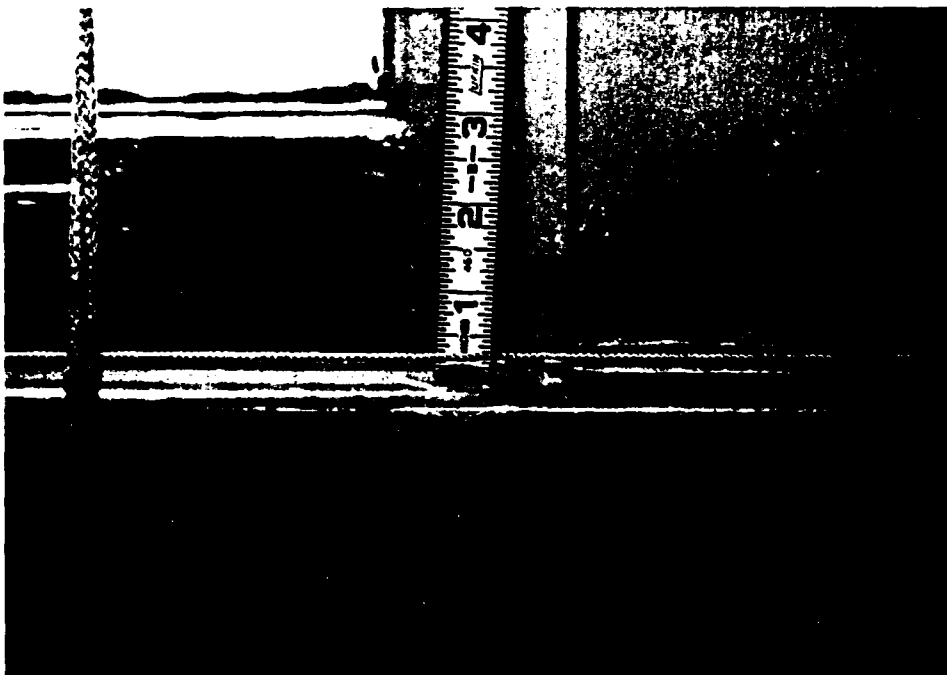
ii. Rooms 212 and 213, deflections were measured at the top and bottom of the three-section window units in the southeast corner of the room. Deflections of about 0.25 in. were observed at the top and bottom of the window trim and sill (Figure 45).

The original drawings indicate that the header beam above the second-story three-section window units consist of three 2 in. by 10 in. members with a span of about 11 ft 3 in. The header beams carry the roof loads. The structural analysis of the header beam revealed that the current dead loads will produce a deflection of nearly 0.30 in. which corresponds reasonably well with the 0.25-in. deflection observed at the top and bottom of the southeast window in Rooms 212 and 213. Moreover, when ponding was considered in the structural analysis, the combined dead and live load stresses in the header beam exceeded the allowable stress by about 52 percent.

The added dead load from the second roof system, ponding, and creep are thought to be the reasons for the sagging observed at the second-story three-section window units.

Figure 45. Deflection of window sill in Room 212.

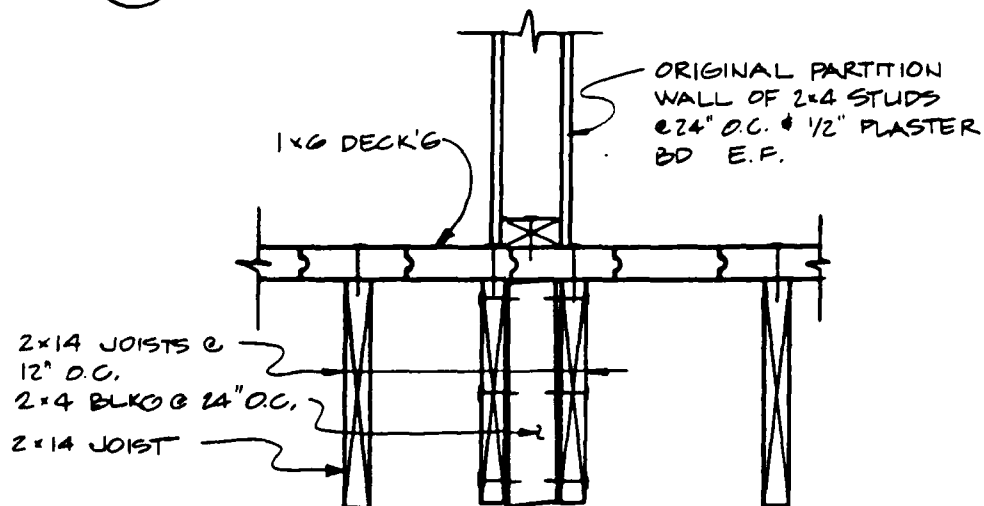
(A) — PARTITION WALL @ RM. 114 DETAIL

typical floor joist and the added joist. Gaps of $1/8$ in. on one side and $1/16$ in. on the other side are evident at the top of the blocking. At the bottom of the blocking, there are gaps of $3/16$ in. and $1/16$ in. on the two sides. The blocking has dropped about $3/8$ in. below the joists. Figures 48 (detail A) and 49 show this condition.
